Case 351 : Narrative

Case Vehicle (A): 2002 Ford	Vehicle (B): 2002 Ford	Vehicle (C): 1998 Chevrolet
Type: F150 XL Sport, 2-door 4x4 pickup	Type: Ranger Supercab, 4-door pickup	Type: GMT 400, 4x2 2-door truck
Driver: 30-year-old male	Driver: 23-year-old male	Driver: 45-year-old male
CDC: 12-RYES-1, 12-RBES-1, 12-FDEW-5	CDC: 99-0000-0	CDC: 99-0000-0

CASE NO.: 351-02

CASE VEHICLE: 2002 Ford

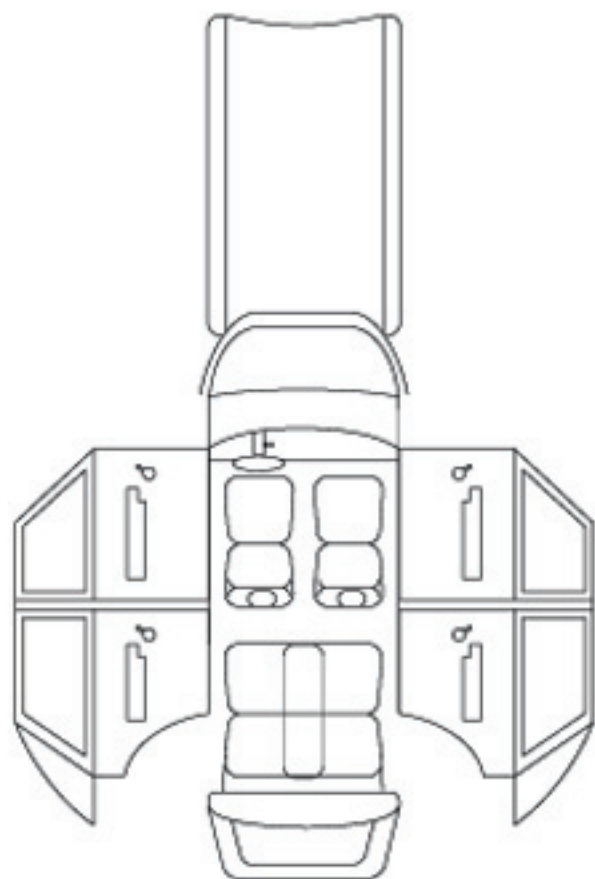
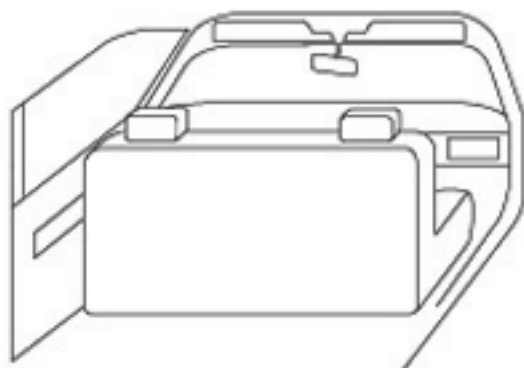
steering wheel positioned at 9:00

evidence of driver belt use:
belt webbing is cut, latch in buckle,
deep scratches on D-ring, pretensioner
fired, transfer marks on webbing from
D-ring

D: airbag, black marks

A: steering wheel,
deformation

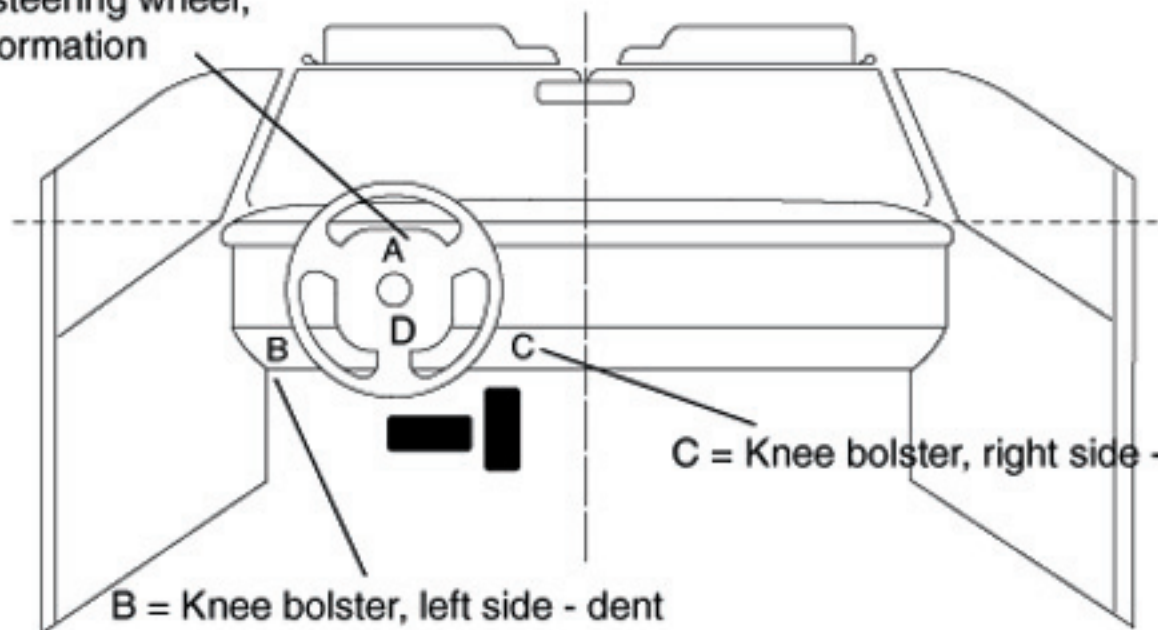
C = Knee bolster, right side - dent

B = Knee bolster, left side - dent
